# **INDOOR AIR QUALITY ASSESSMENT**

**Memorial Elementary School  
125 Winn Street  
Burlington, Massachusetts**

Prepared by:  
Massachusetts Department of Public Health  
Center for Environmental Health  
Bureau of Environmental Health Assessment  
Emergency Response/Indoor Air Quality Program  
September 2004

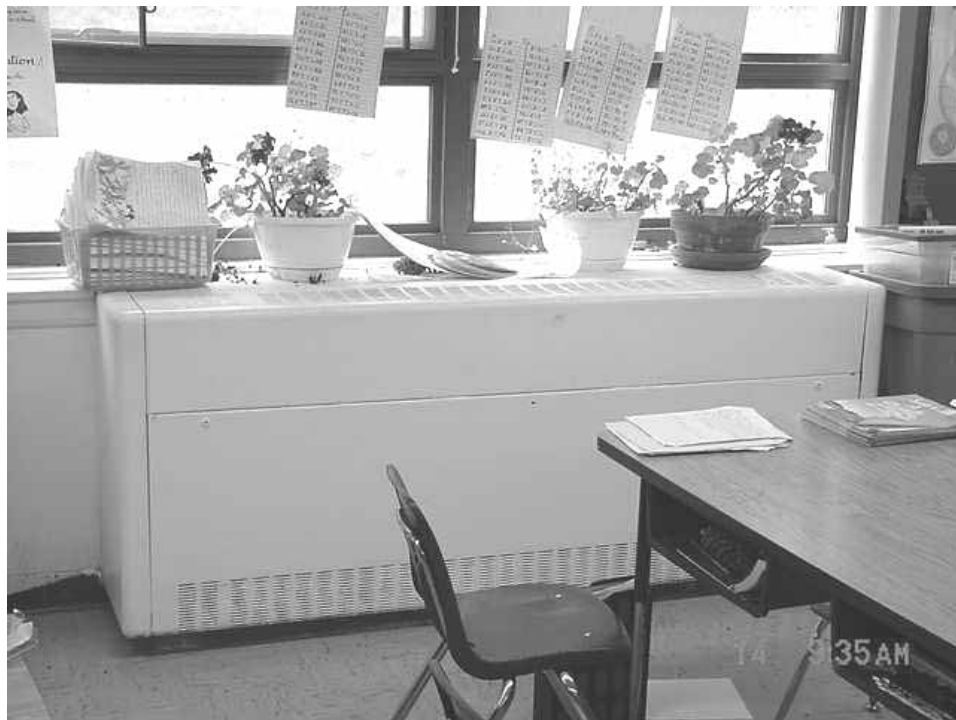
**Picture 1**

Fresh air in classrooms is supplied by a unit ventilator (univent) system ([Picture 1](#)). A univent draws air from outdoors through a fresh air intake located on the exterior wall of the building (Picture 2) and returns air through an air intake located at the base of the unit (Figure 1). Fresh and return air are mixed, filtered, heated and provided to classrooms through an air diffuser located on the top of the unit. The majority of univents were operating during the assessment; however, a few had been deactivated by occupants due to excessive noise. Obstructions to airflow, such as papers and books stored on univents and items in front of univent returns were seen in a number of classrooms (Picture 3). In order for univents to

**Vintage 1950s Classroom Univent, Note Flowering Plants Near Air Diffuser**

1. Ensure all operable ventilation systems (supply and exhaust) throughout the building (e.g., classrooms, gym, auditorium) are operating continuously during periods of school occupancy.
2. Inspect exhaust motors and belts for proper function. Repair and replace as necessary.
3. Remove all blockages from univents and exhaust vents to ensure adequate airflow.
4. Consult a ventilation engineer concerning re-balancing of the ventilation systems.  
Ventilation industrial standards recommend that mechanical ventilation systems be balanced every five years (SMACNA, 1994).
5. Ensure any roof/plumbing leaks are repaired. Replace any remaining water-stained ceiling tiles (for dropped ceilings). Examine the areas above and around these tiles for mold growth. Disinfect areas of water leaks with an appropriate antimicrobial.

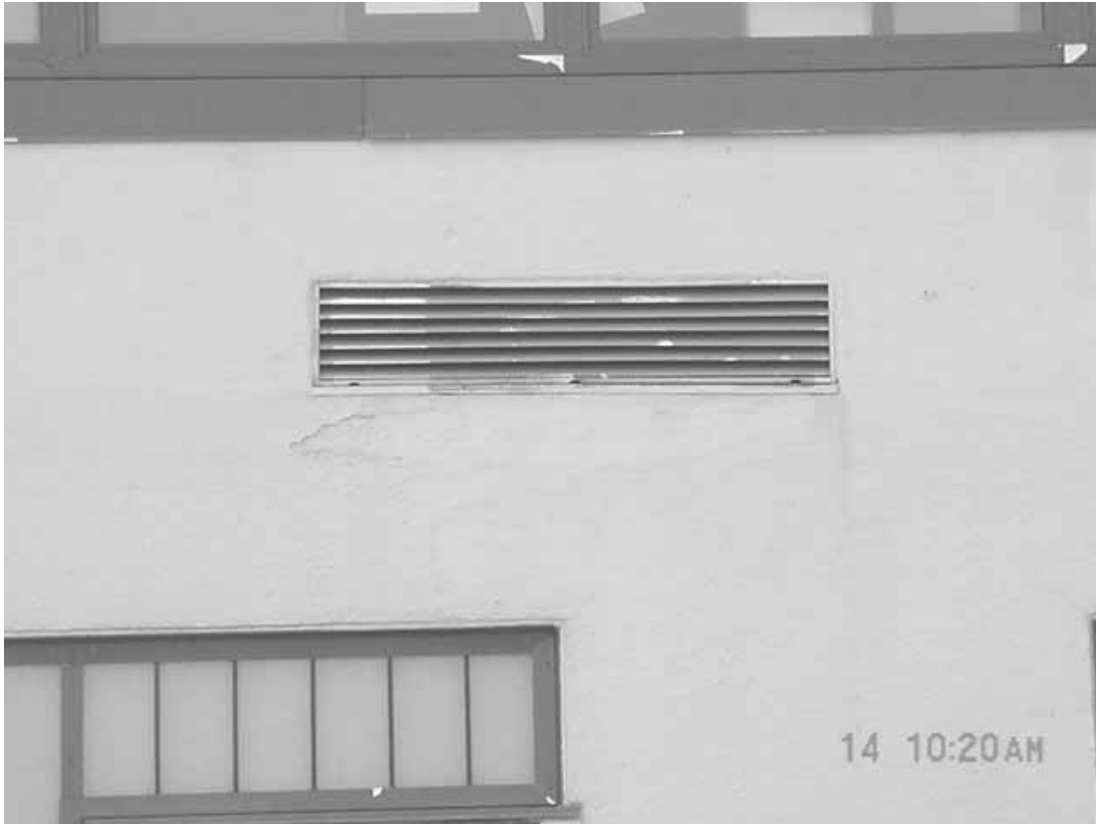
**Picture 2**

**Univent Air Intake**

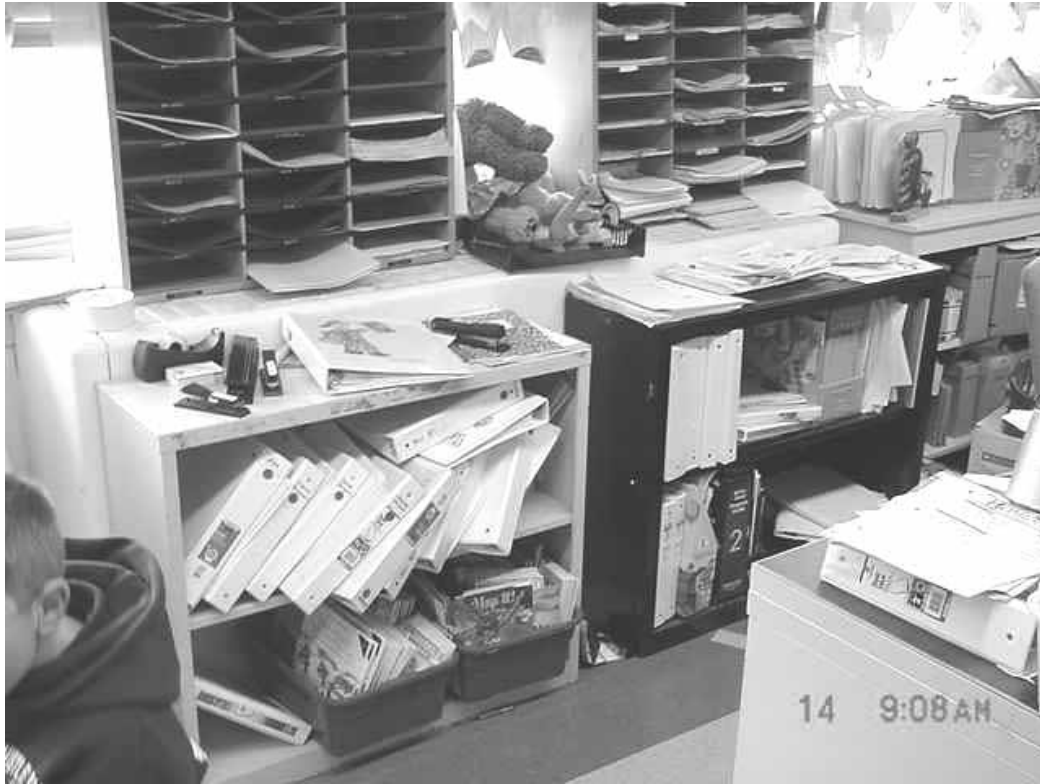
**Picture 3**

provide fresh air as designed, these units must remain free of obstructions and allowed to operate while rooms are occupied.

**Univent Obstructed on Top and in Front by Various Items**

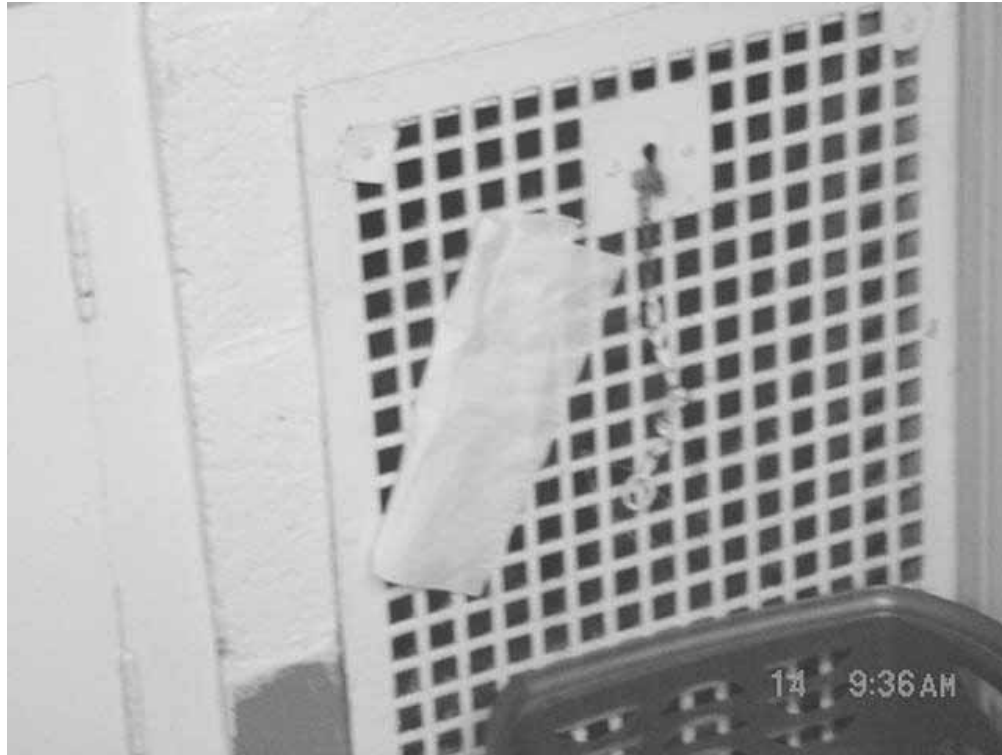
**Picture 4**

Exhaust ventilation in classrooms consists of wall-mounted grilles (Picture 4), which are powered by rooftop motors. The draw of air into these vents is controlled by a pull chain/louver system (Picture 4). Many of the pull chains and louvers were not operable or were missing. The exhaust system was not functioning or was drawing weakly in a number of areas surveyed, indicating that motors had been deactivated or were non-functional. In order to function properly the ventilation system must be restored to its original design by repairing/replacing control systems. A number of exhaust vents were also obstructed by tables, chairs, boxes and other items (Picture 5). As with the univents, in order to function properly, exhaust vents must be activated and remain free of obstructions. Without sufficient supply and exhaust ventilation, environmental pollutants can build up and lead to indoor air quality/comfort complaints.

**Classroom Exhaust Vent, Note Pull Chain**

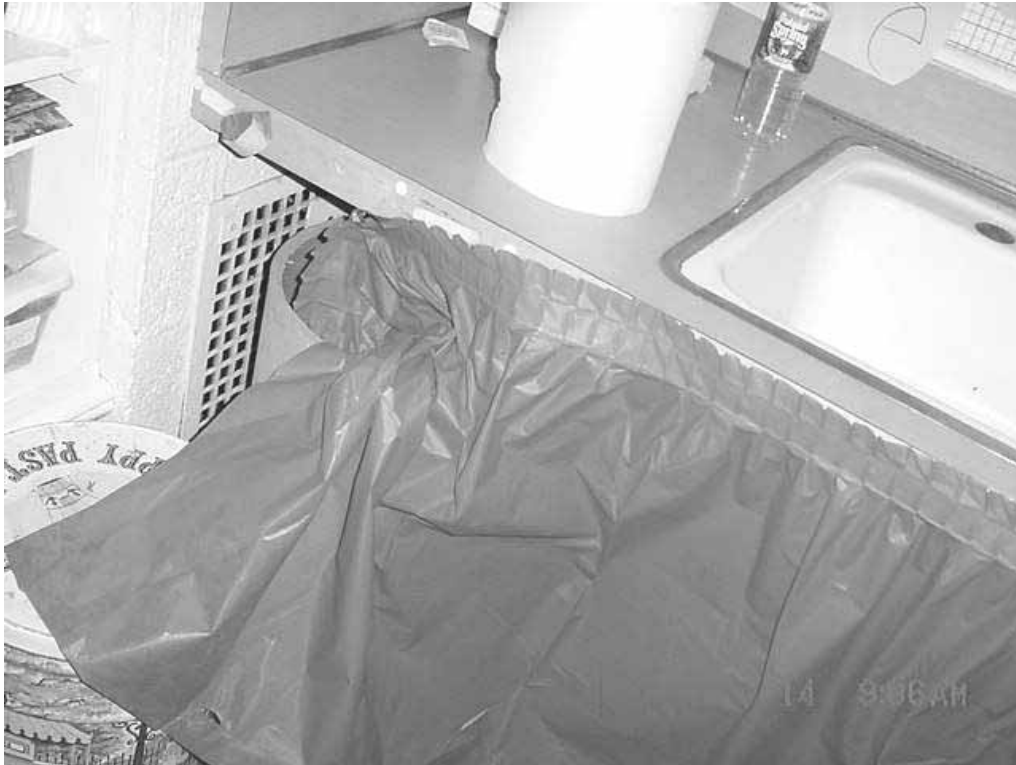
**Picture 5**

**Classroom Exhaust Vent Obstructed by Curtain around Sink and Other Items**

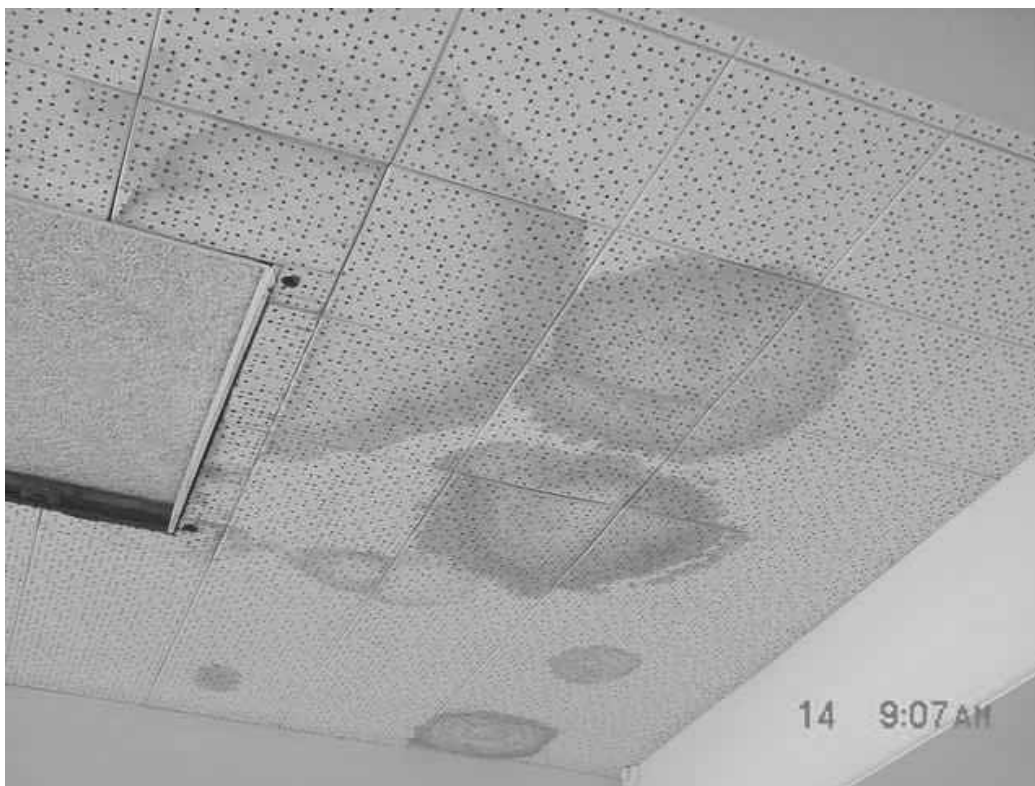
**Picture 6**

A number of areas had water-damaged ceiling tiles, which is evidence of historic roof or plumbing leaks. In many cases these water damaged ceiling tiles were observed around skylights that had been sealed to prevent leakage (Picture 6). In classrooms, water damaged ceiling tiles are part of an interlocking system, which makes removal difficult. The ceiling tile system in hallways consists of drop ceilings, which are relatively easy to change. Water-damaged ceiling tiles can provide a source of mold growth and should be replaced after a water leak is discovered and repaired. No active leaks were reported in the school at the time of the assessment.

**Water-Damaged Interlocking Ceiling Tiles**

2. Remove ceiling tiles using adequate containment methods. Replacement of ceiling tiles may also involve glues that contain VOCs. In order to minimize occupant exposure, repairs should be done while the building is unoccupied.

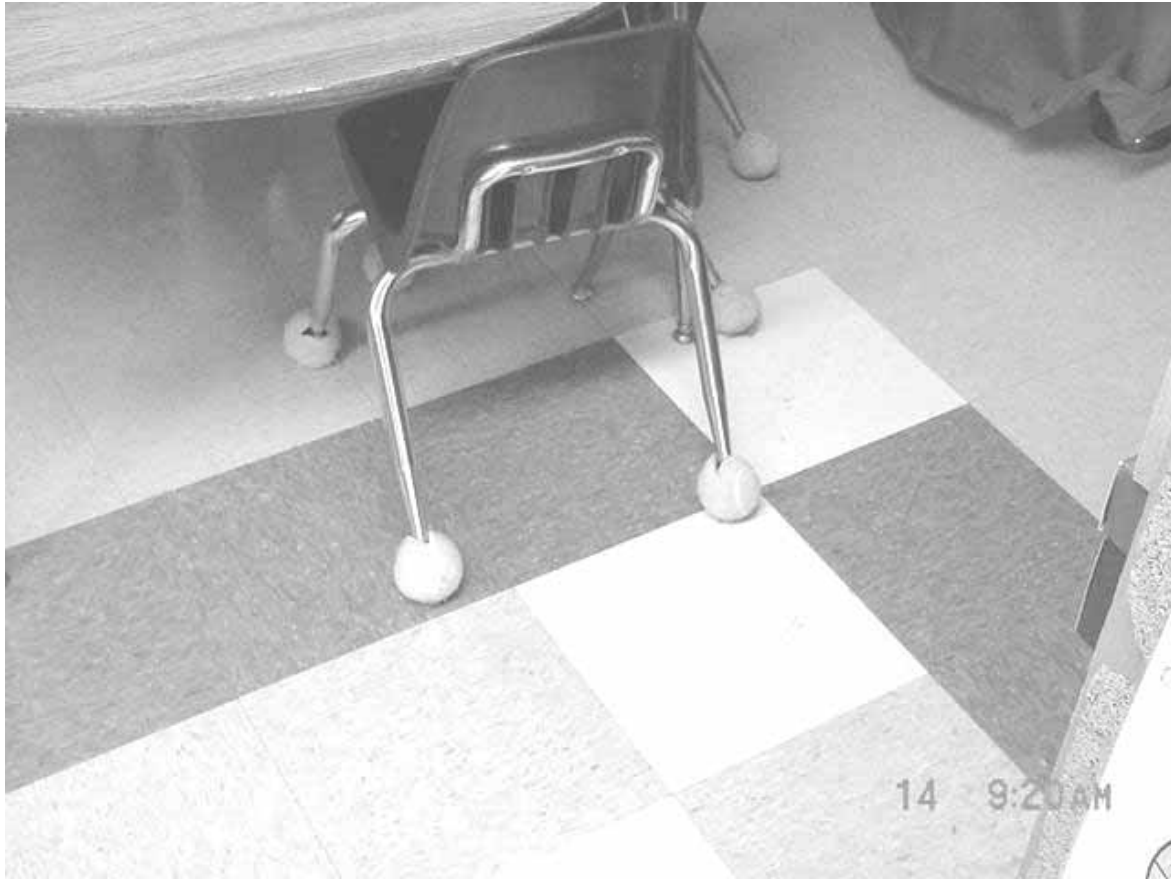
**Picture 7**

Finally, in an effort to reduce noise from sliding chairs, tennis balls had been cut open and placed on chair legs (Picture 7). Tennis balls are made of a number of materials that are a source of respiratory irritants. Constant wearing of tennis balls can produce fibers and off-gas VOCs. Tennis balls are made with a natural rubber latex bladder, which becomes abraded when used as a chair leg pad. Use of tennis balls in this manner may introduce latex dust into the school environment. Some individuals are highly allergic to latex (e.g., spina bifida patients) (SBAA, 2001). It is recommended that the use of materials containing latex be limited in buildings to reduce the likelihood of symptoms in sensitive individuals (NIOSH, 1997). A question and answer sheet concerning latex allergy is attached as [Appendix B](#) (NIOSH, 1998).

**Tennis Balls on Chair Legs in Classroom**

9. Consider discontinuing the use of tennis balls on chair legs.
10. Consider adopting the US EPA (2000b) document, *Tools for Schools*, in order to provide self-assessment and maintain a good indoor air quality environment at your building. The document can be downloaded from the Internet at <http://www.epa.gov/iaq/schools/index.html>.
